MONROE CITY SOUTH LAKE DAM
MONROE COUNTY, MISSOURI
MO. 10538

**PHASE I INSPECTION REPORT
NATIONAL DAM SAFETY PROGRAM**

NOVEMBER 1979

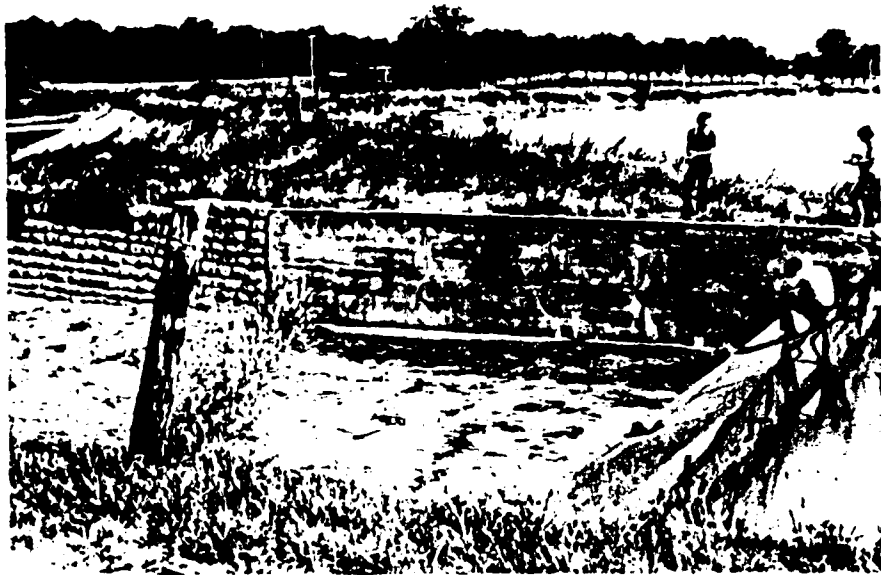
Photo 5

The spillway has apparently had a concrete cap added to it as evidenced by the condition of the concrete relative to the rest of the spillway. This accounts for the difference between what is shown on the available drawings and field measurements made by the inspection team. The concrete on the downstream side of the weir, immediately below the cap, has undergone severe spalling. Reinforcement is exposed on the right side of the spillway (as viewed looking downstream). Standing water was also observed in this location. Immediately downstream of the weir, on the right wingwall, leaching deposits were observed. Some minor temperature cracks were observed in the spillway cap along with a small amount of spalling on the upstream side. No displacement was observed in construction joints. The concrete wingwalls appeared to be in good condition. The discharge apron has deteriorated severely as a result of cracking and spalling.

- Photo 4. - View of the approach to the spillway.
- Photo 5. - View of the spillway and the discharge channel. Note leaching of retaining walls and spalling of concrete in the discharge channel.

1. Deteriorated concrete should be removed from the spillway and discharge apron and repairs made to the damaged areas.
2. All brush should be cleared from the upstream slope.
3. The erosion along the upstream crest should be repaired and the area should be protected with proper riprap to prevent future erosion.
